D: Cambodia Mines

PMD-6 ANTI-PERSONNEL MINE

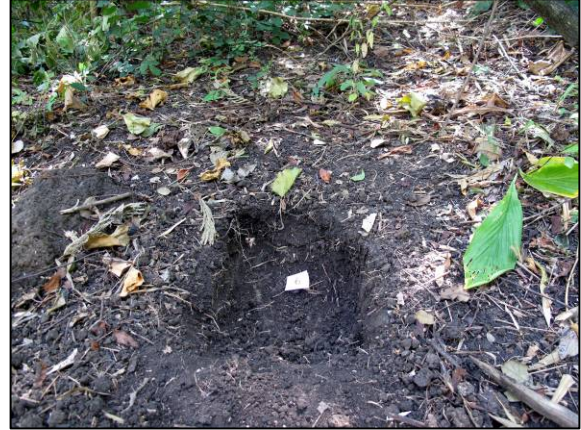
A typical recovery site (mine 6)

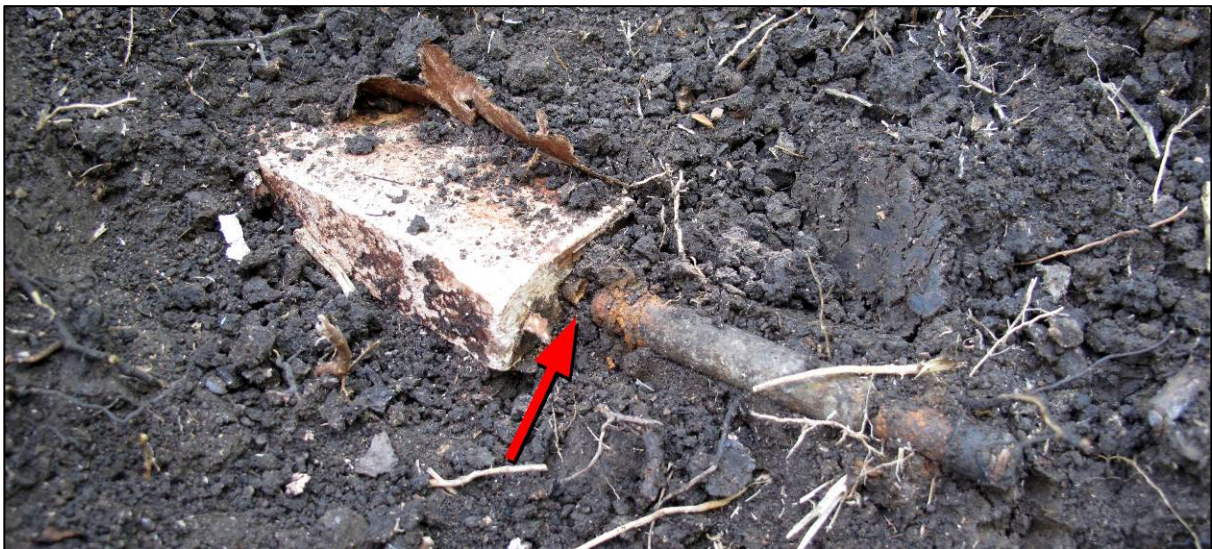
None of the wood casing remains from mine 6. There is a clear break between the fuze and the TNT block (indicated by the red arrow); this was filled with mud.

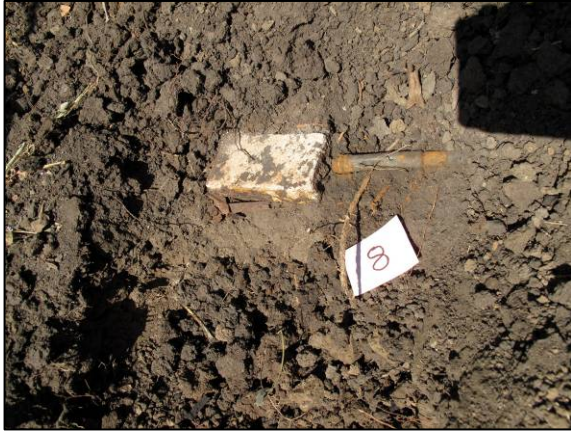
Every PMD-6 mine recovered had a break between the fuze and the charge

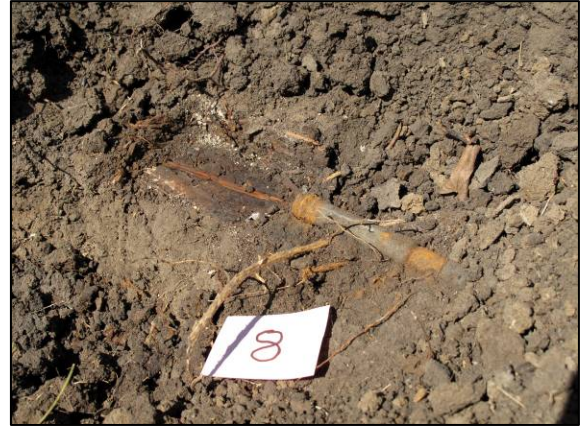
Remnants of the wooden casing are visible once the TNT charge has been removed

- The wooden case of every PMD-6 had rotted, with only small remnants found. Since the casing forms part of the initiation system (by pushing the retaining pin out to release the striker), these mines could no longer function as designed.
- The MUV-2 fuze components were intact, but were seized and had to be separated using force. The stab receptors were in poor condition and were probably not functional.
- The upper section of the aluminum detonator tube had corroded away, leaving a break of approximately 5-10 mm between the fuze and the main charge. This gap was filled with mud, which would probably have prevented the flash from the stab-receptor from initiating the detonator.
- Burning tests on two charges resulted in eventual detonation, indicating that the primary explosive within the detonator was still viable, and capable of initiating the main TNT charge.

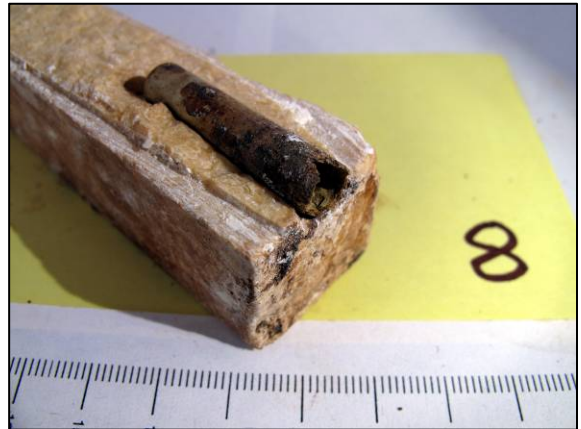
The TNT block broken open to show the corroded detonator tube

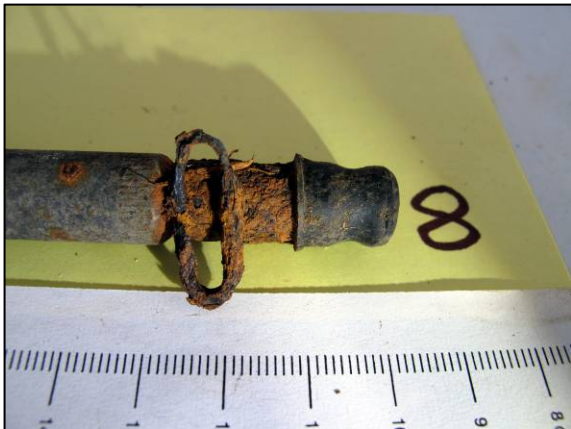
The retaining pin of fuze 8 was almost rusted through, but the striker was seized

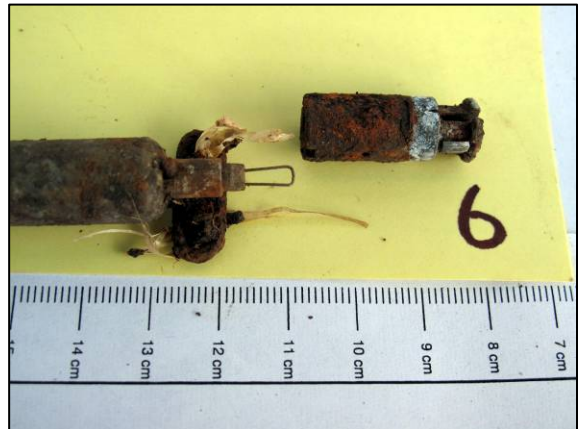
The retaining pin of fuze 6 was in relatively good condition

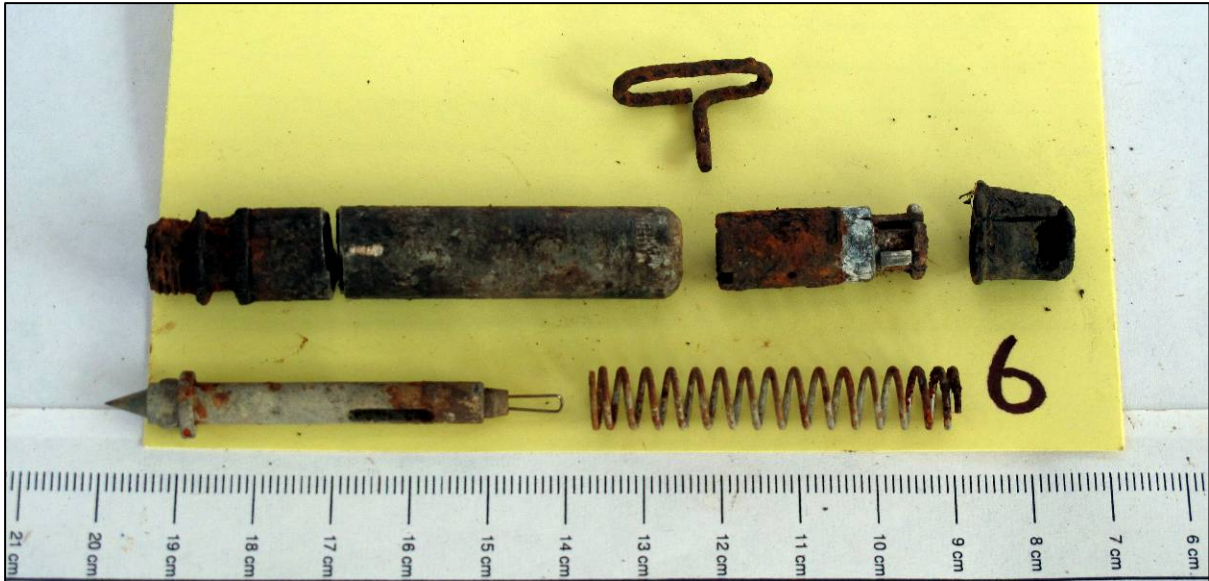
The mechanical components of fuze 6 might have been operational, but it is unlikely that the stab receptor would have functioned

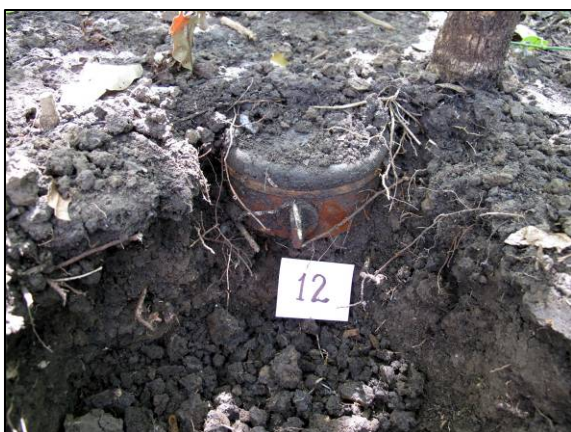
A close-up showing how the roots have grown around mine 12

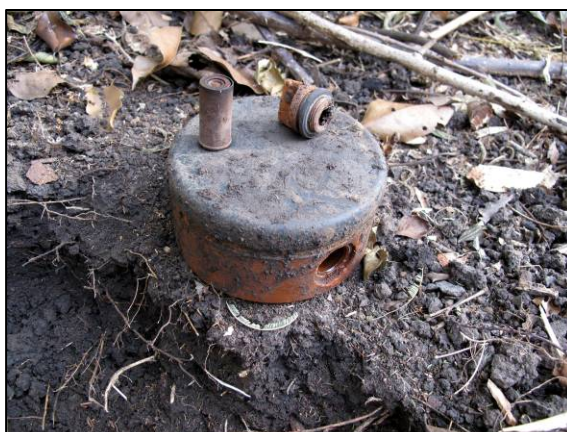
The PMN with detonator removed; in some mines the detonator could not be extracted

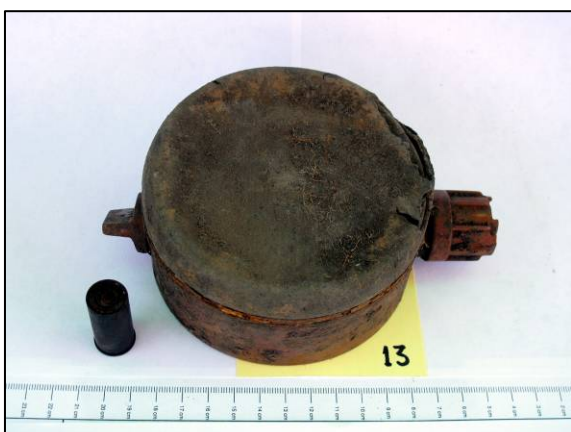
Some of the rubber covers were damaged, allowing water to enter the mine body

- Rubber covers had deteriorated and hardened; some, but not all, were breached. This does not prevent the mine from working, but does allow water into the fuze mechanism.

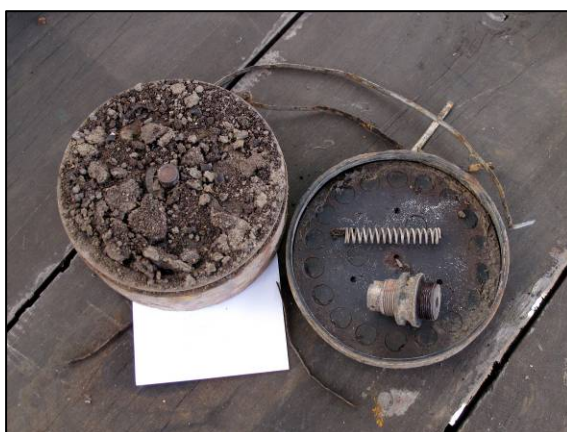
In some cases, soil had almost filled the void beneath the pressure plate

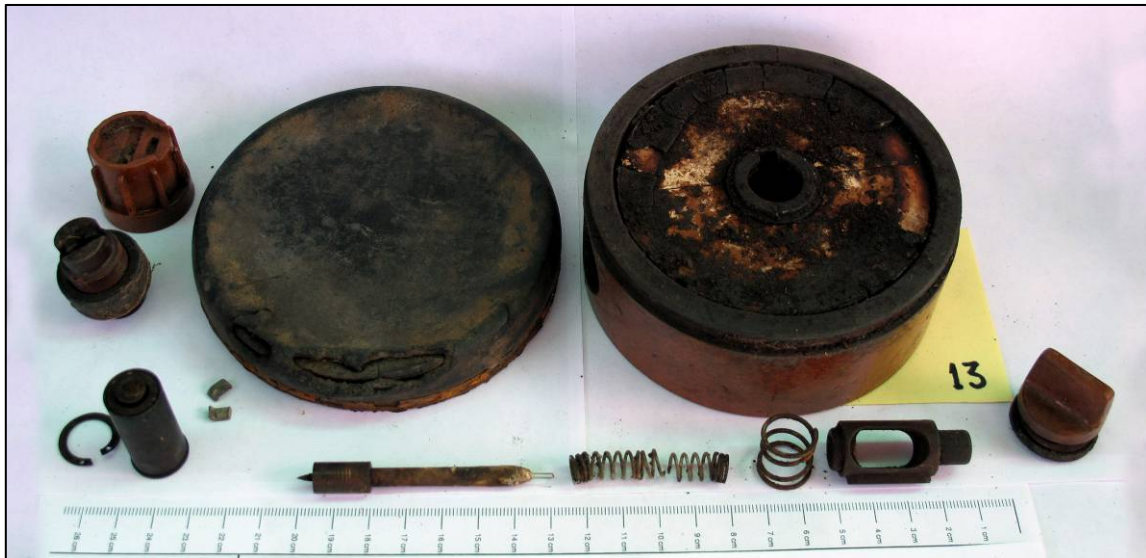
Components of mine 13 with TNT charge still in place within the body. The mine may have been functional despite the striker spring being badly deteriorated

- The main effect of water inside the mine is to cause the springs to rust. The striker spring is most critical to failure; however, deterioration of the plunger spring could potentially lead to a decrease in operating pressure.

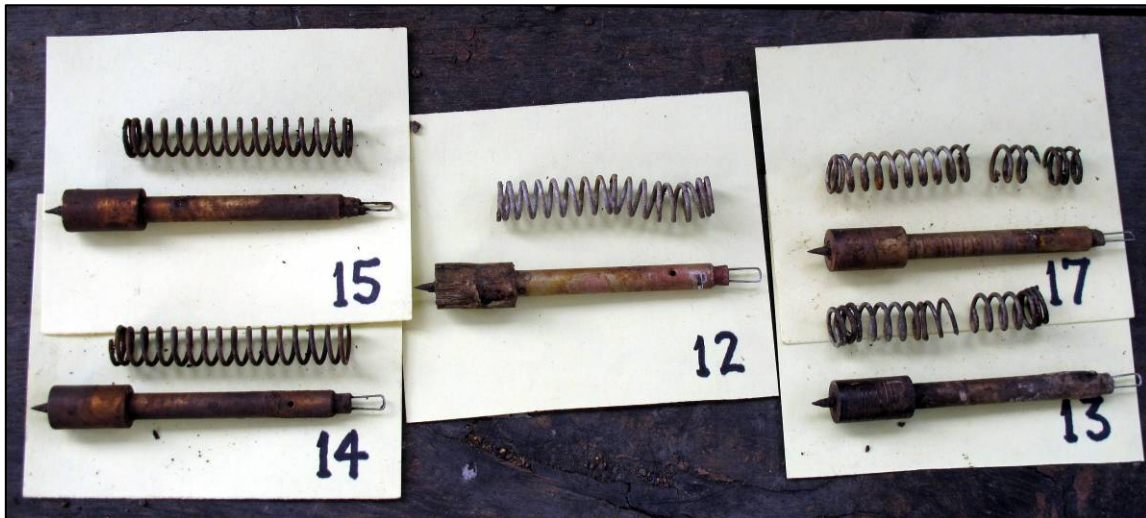
Strikers and springs showed substantial variation in the degree of degradation

- As noted in the previous report, springs in contact with alloy strikers appear to deteriorate more quickly than those around steel strikers.
- Most strikers were in operational condition, but one had deteriorated badly and was seized into its channel. This would have caused the initiation mechanism to fail.

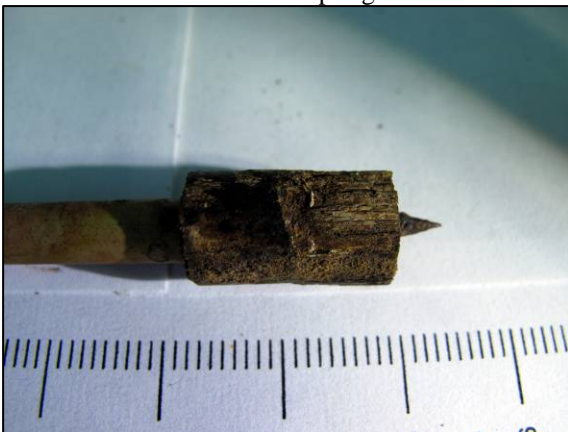
Striker 12 was badly corroded and seized; this would have prevented operation

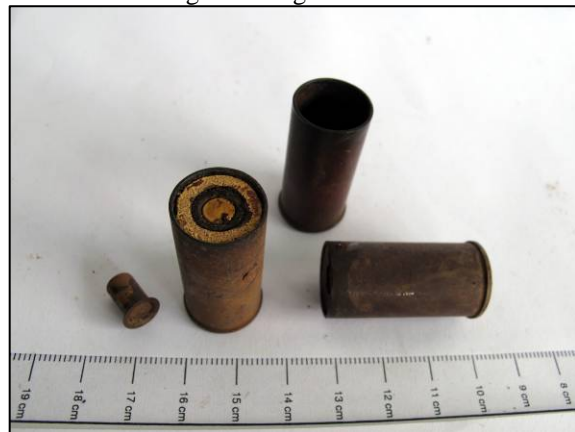
Most detonator capsules were functional, confirmed by explosive testing

- TNT charges were in good condition and detonators appeared to be functional. Two detonator tests (using a PMN fuze mechanism in good condition) resulted in detonation.

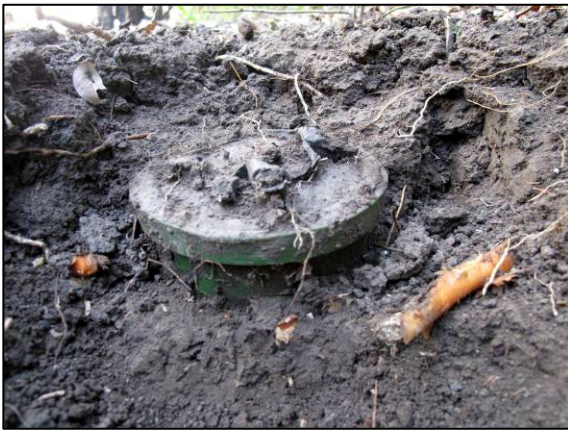
Deterioration of the rubber pressure plate cover

- The rubber pressure plate covers were badly perished, with large sections missing. In several examples, the top edge of the plastic casing was also split. This damage would not prevent the mine from working, but does allow water into the fuze mechanism.
- The main effect of water inside the mine is to cause the springs to rust. The striker spring and detonator slider spring are both critical to operation and their deterioration can cause failure.

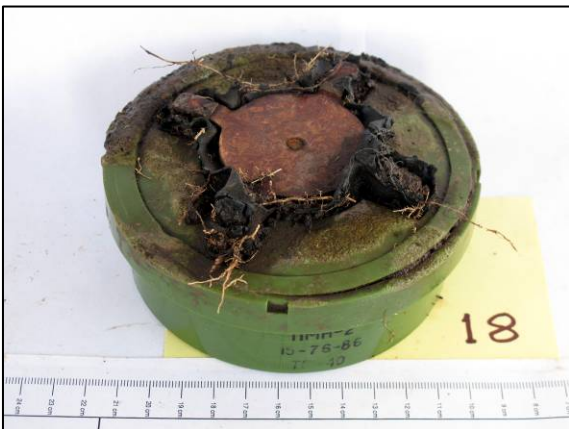
The mine cleaned to show the extent of the rubber and casing degradation

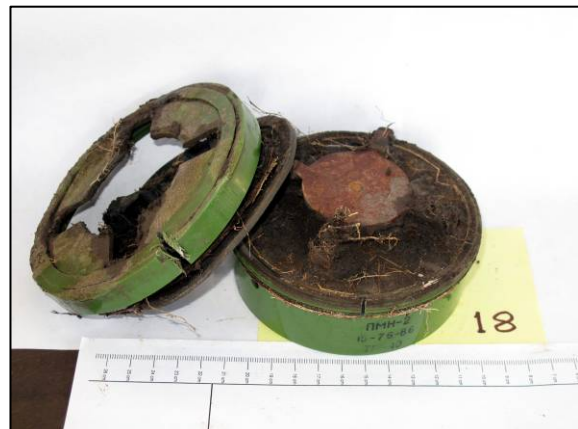
Removal of the securing ring reveals the penetration of soil and roots

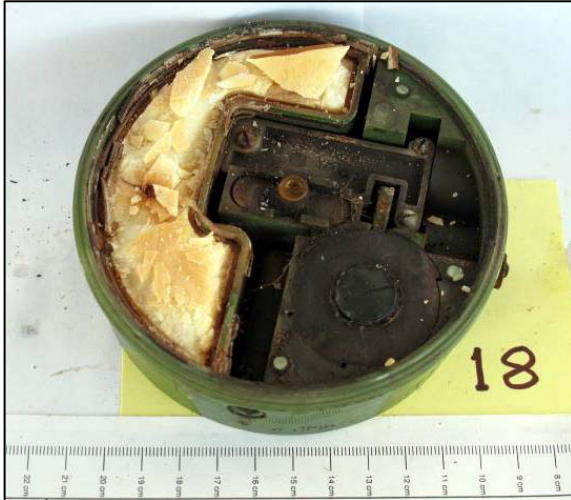
Top plate removed to show the main charge (to the left) which is in good condition. The fuze mechanism (to the right) has degraded

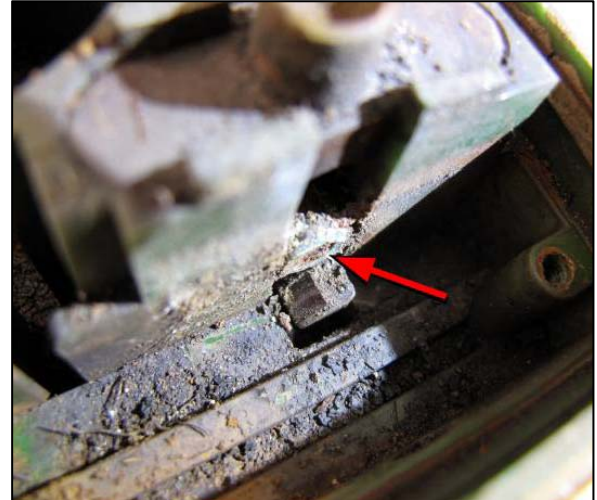
A close-up showing the end of the striker. The arrow indicates where the firing pin should be, but this has rusted away completely

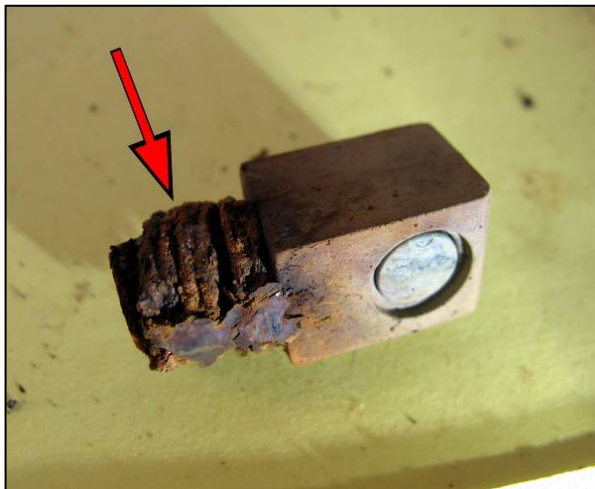
The slider containing the detonator. The arrow indicates the spring, which should move the detonator into line with the striker as the mine is actuated; this spring is no longer functional

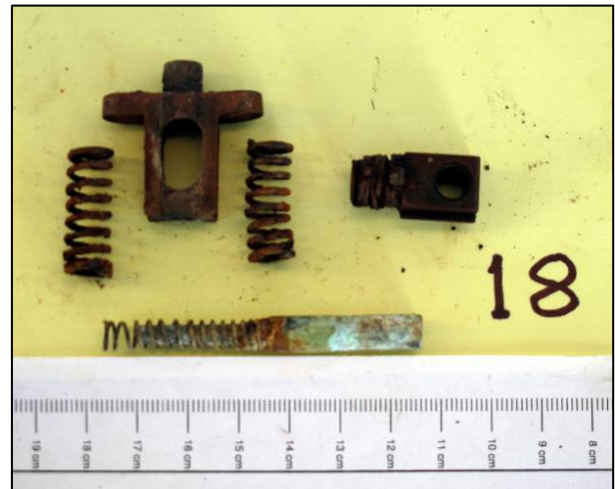
Components of the fuze mechanism, showing that all springs were badly rusted. The plunger (top left) and striker (below) were firmly seized into their channels

- Deterioration of the plunger springs could potentially lead to a decrease in operating pressure, but appears to be offset by seizing of the plunger itself.
- In every PMN-2 examined, the striker was seized into its channel; this appears to be caused by a build-up of corrosion, leading to expansion beneath the metallic plating.
- In several examples, the steel firing pin (which is inset into the end of the alloy striker) had rusted away completely, leaving the striker with a flat end.
- In all examples, the explosive charges (RDX/TNT) and boosters were in good condition and detonators appeared to be functional. However, the detonator is held out of line until the mine is actuated, and relies on the slider spring to bring it into line.

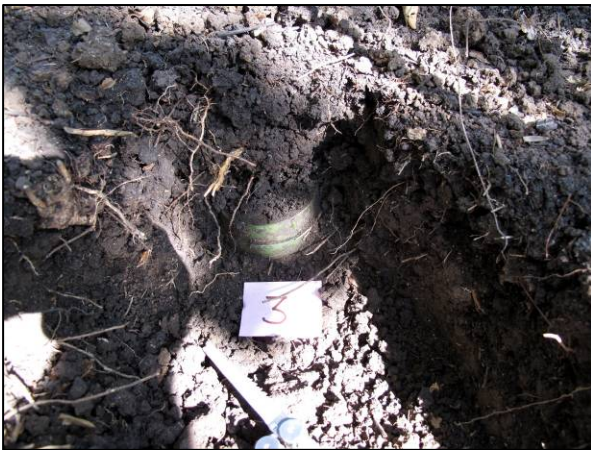
Mine 3 was unusual because it was found buried upside down

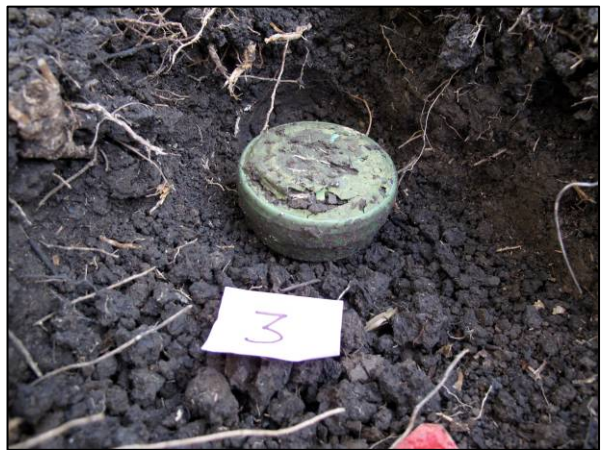
The rubber cover on mine 3 was better preserved than most

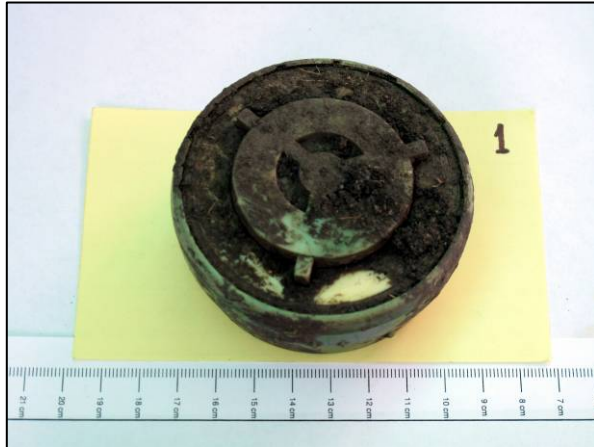
With the rubber cover missing, the Type 72 is penetrated by water and soil

- The rubber pressure plate cover was badly perished or absent in all of the mines examined. In every case, this had allowed water and soil to penetrate the mine body.

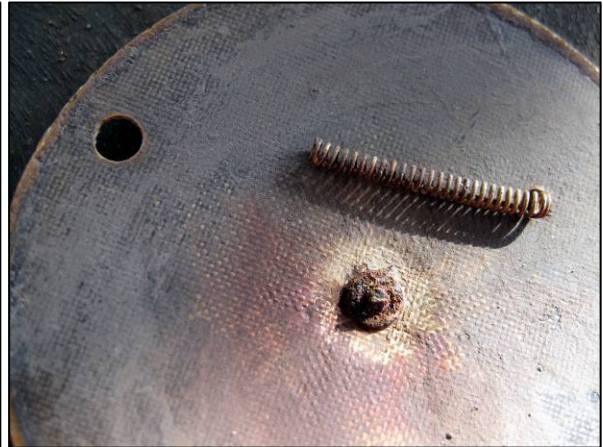
The tip of this firing pin has rusted away, leaving the mine unable to function

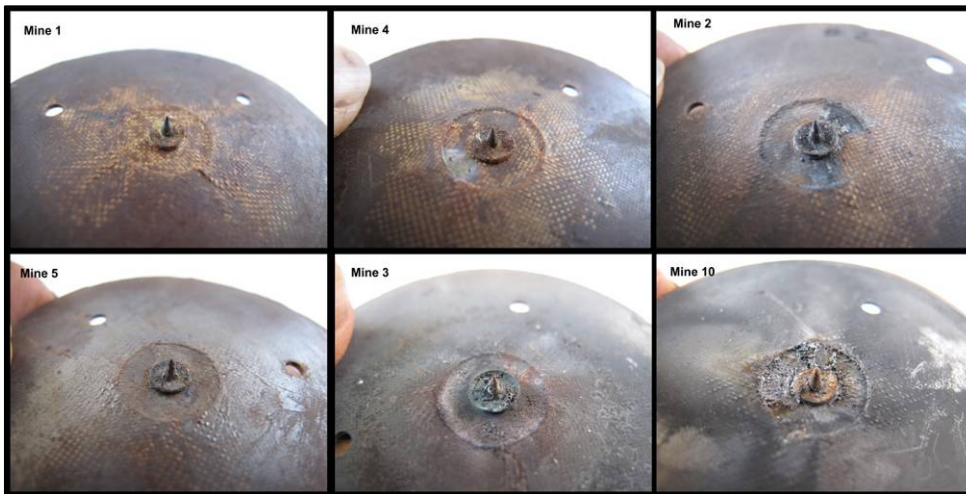
Most of the mines recovered had firing pins in reasonable condition, though superficial rusting had rounded off the ends, making them less likely to fire the igniter

- The primary effect of water inside the mine is to rust the mild steel firing pin. Initially, this causes the tip to become rounded and therefore shorter, which makes it far less likely to fire the igniter.

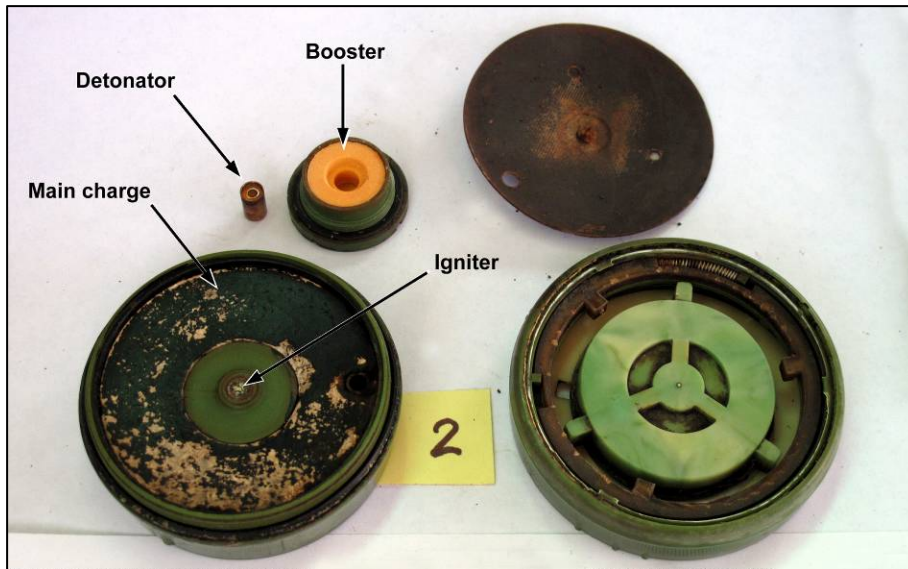
The main charge, booster and detonator appeared to be functional in most of the mines recovered. However, some of the igniters had deteriorated.

Function tests using firing pins in good condition confirmed that some igniters were no longer operational

- Most explosive components remained in reasonable condition and appeared to be functional. However, some of the stab-sensitive igniters were no longer operational.
